General Observations and Discussions.

| CONTRACT | 805-817 Mamre Road Kemps Creek | Western Earth Moving (WEM) | | DATE OF INSPECTION | 31/8/26 | |

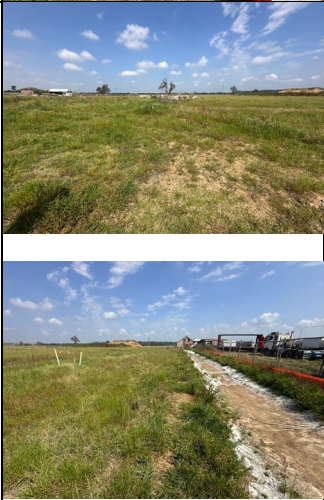
| 6. | Condition of Erosion controls & Vegetation | | <b>OBSERVATION 24/9/26</b> | The ER verified that the vegetation and established erosion controls are in good condition and no maintenance appears to be required. Clean water drains were in good condition. | N/A | |

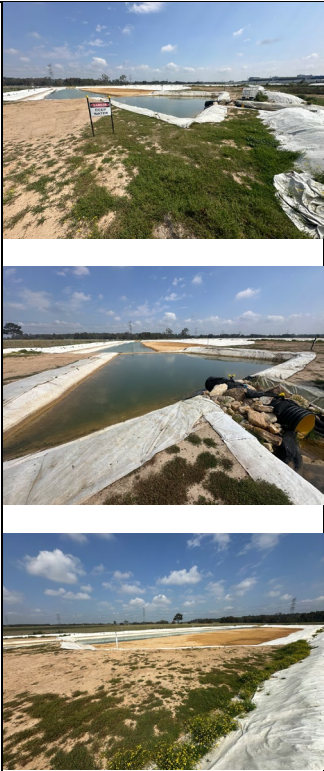
| 7. | Sediment Basin | | | <p>Due to the high level of natural stabilisation via ground cover, the CPESC has confirmed soil loss calculations do not require a basin as yet. This allows the basin to be left as-is.</p> <p>The basin appears in good condition and ready to operate as designed once soil loss calculations trigger its use (and replenishment of treatment polymer)</p> | | |
